Instructions for Sunways Solar Inverter software updates

This document contains detailed instructions for software updates for Sunways Solar Inverters of the following types:

- NT series 900 V (NT 2500...NT 5000)
- NT series 900 V (NT 10000...NT 12000)
- AT series (AT 2700...AT 5000)
- PT series (PT 30k, PT 33k)

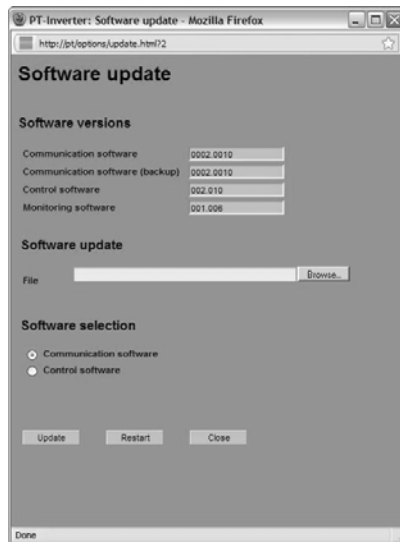
to access the settings. Click on Software Update to open the following window:

AT series, PT series (COM < 4.0)

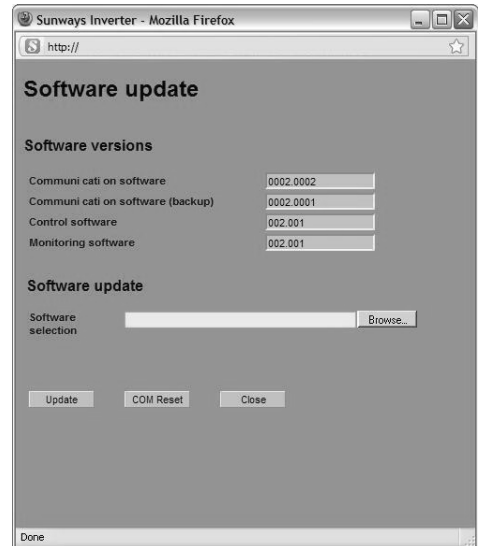
NT series, AT series, PT series (COM ≥ 4.0)

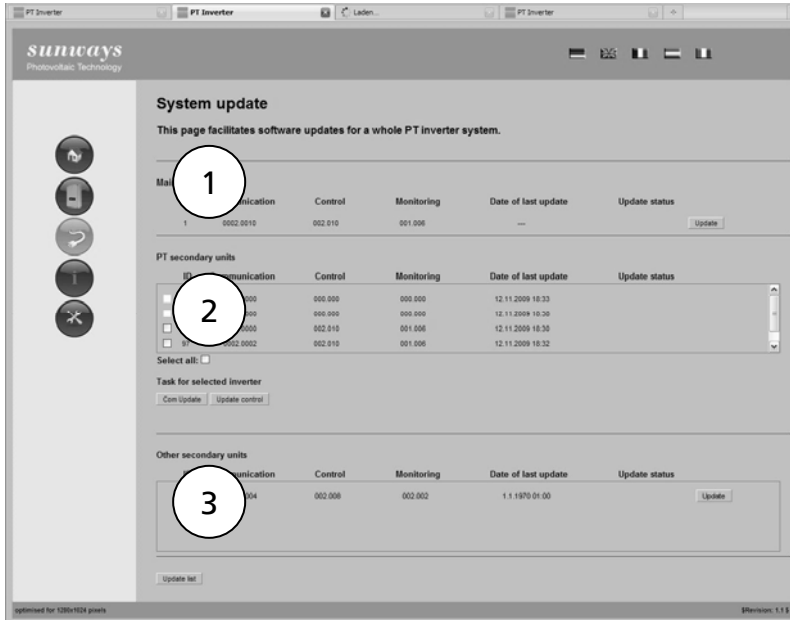
5.1 Older version: AT, PT series (COM version < 4.0)

1 Section 1: Master
This section provides information on the software status of the master. Click on Update to open the dialog box for updating the master.

Section 2: Slaves
This section provides information on the software status of Solar Inverters from the same device family in the CAN network. Tick the checkboxes for the required devices or select all (recommended).
Click on Comm. Update and Control Update to update the respective software. The communication software is distributed from the master to the respective slaves. The control software first has to be uploaded. Click on "Browse..." and select a file. The selected devices are then updated successively. If the update is successful the message "updt. OK" appears.
Please note: If a device is in overnight shutdown mode, the update automatically takes place the next day. The control software update does not continue after an overnight shutdown.

Section 3: Other slaves (PT and AT < 4.0)
The Update button links to the dialog box for updating another slave separately. The procedure is described in more detail in section 6
