Instructions for Sunways Solar Inverter software updates

This document contains detailed instructions for software updates for Sunways Solar Inverters of the following types:

- NT series 900 V (NT 2500...NT 5000)
- NT series 900 V (NT 10000...NT 12000)
- AT series (AT 2700...AT 5000)
- PT series (PT 30k, PT 33k)

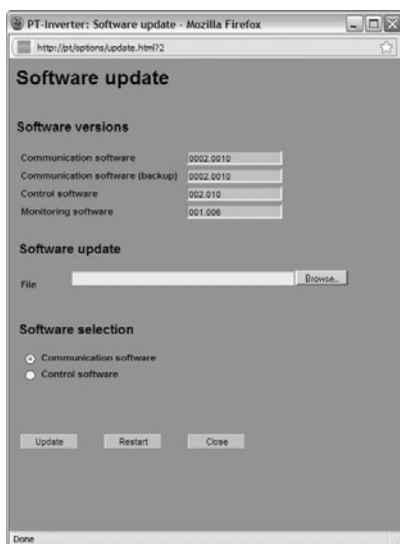
to access the settings. Click on Software Update to open the following window:

AT series, PT series (COM < 4.0)

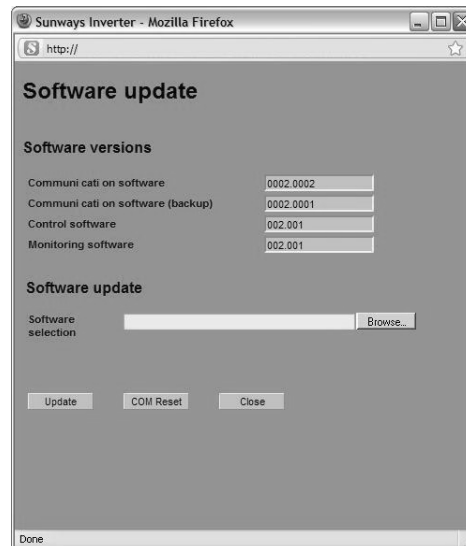
NT series, AT series, PT series (COM ≥ 4.0)

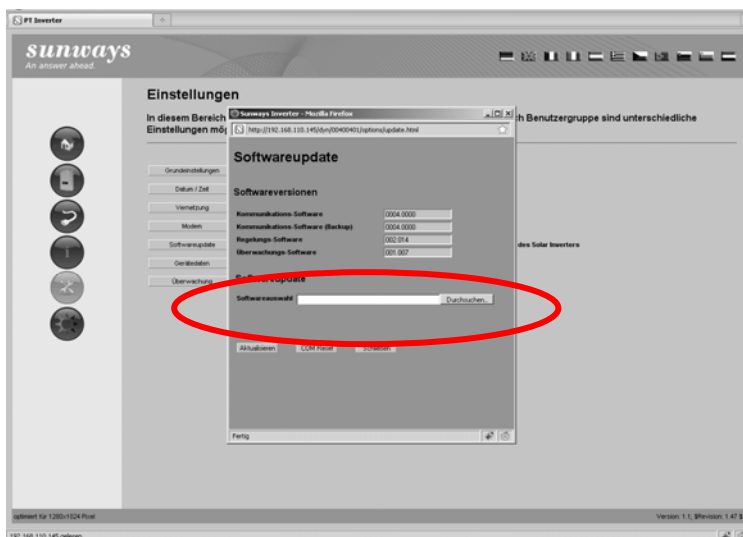
1. Update of the software [PT COM 4 0 M.gz](#) (with PT) resp. [AT COM 4 0.gz](#) (with AT) via menu «Settings» - «Software Update»
